CASE STUDY—CHARLOTTE, NC

CASE STUDY—PRINCETON, NJ

CASE STUDY—GOSHEN, NY

CASE STUDY—ST. LOUIS, MO

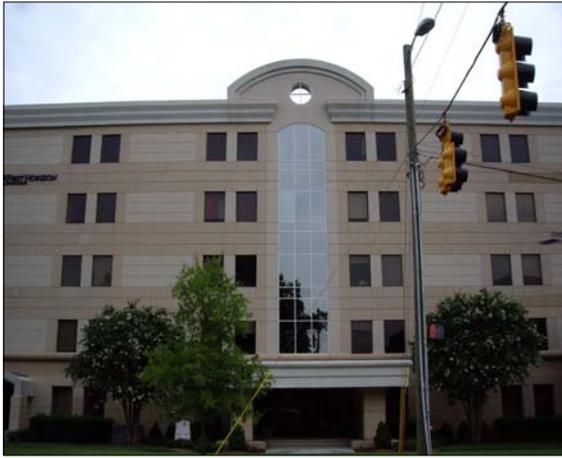
- EIFS OVER CMU CONSTRUCTION WITH CURTAIN WALL WINDOW STACKS
- MOISTURE PENETRATION THROUGH ORIGINAL 1970'S WINDOWS
- PURCHASING CLIENT CONCERNED ABOUT EIFS APPLIED IN 1990 AND GENERAL BUILDING ENVELOPE PERFORMANCE

Open wall investigation revealed long term moisture migration into the window stacks. Moisture flowed down the stack and entered the interior working area at window heads.

It was determined the EIFS cladding had been installed over the exterior window sill blocking the window weeps. This forced moisture inward which flowed down the curtain wall.

Solution: MoistureFree Commercial Services investigation determined that the EIFS had a remaining useful service life of 20 years, provided that some maintenance and limited repairs were made. However, a serious moisture concern with the window systems was discovered, which had been affecting the building for many years.

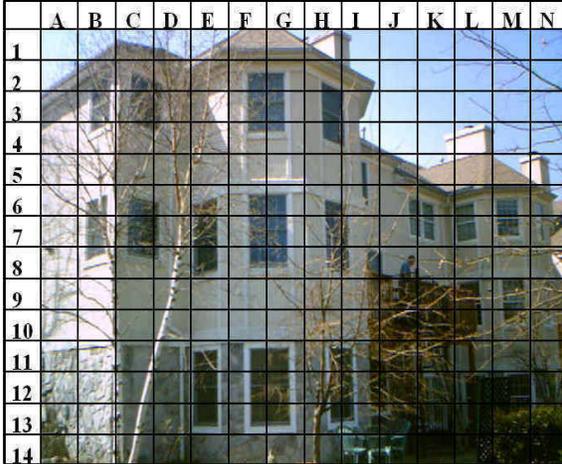
- 46 BUILDING COMPLEX OF HIGH END TOWN HOMES
- MIX OF BARRIER AND DRAINABLE EIFS OVER LIGHT WOOD FRAME
- ATTORNEYS CONVINCED HOMEOWNERS ASSOCIATION THAT THE EIFS MUST BE REMOVED AT AN ESTIMATED COST OF \$18 MILLION

High moisture locations associated with windows occurred at a frequency nearly ten times less than average. Windows that did leak could be easily modified.

Failed flashing locations were the only significant location of moisture and damage. These limited areas did require repair and modification, but did not justify complete recladding.

Solution: MoistureFree Commercial Services was hired to provide expert witness services and analysis of the buildings. A thorough investigation of the buildings revealed that they were in excellent condition with the exception of limited flashing areas that required modification. MoistureFree's extensive database of more than 18,000 buildings and over 1.5 million data points provided solid evidence to back up the opinion that the buildings have a reliable cladding system. MoistureFree Commercial Services provided the estimated modification costs for the facility and backed the proposal with the guaranteed issuance of the MoistureFree Warranty following remediation by MFCS.

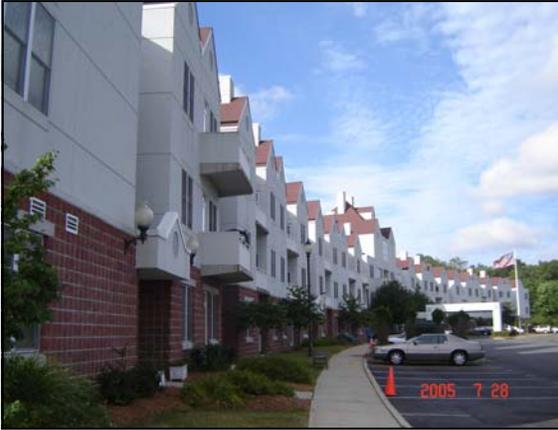
- ASSISTED LIVING FACILITY WITH EIFS AND SPLIT BLOCK EXTERIOR
- MOISTURE PENETRATION CAUSED BY MULTIPLE SOURCES THROUGHOUT THE COMPLEX
- DIRECT MOISTURE PENETRATION TO THE INTERIOR LIVING SPACE AND IAQ ISSUES AFFECTING TENENTS

Spray rack and negative pressure testing of the windows revealed chronic problems in the windows design.

Interior damage to the steel stud walls was apparent in some areas of the facility. MoistureFree repaired these areas and eliminated the source of the IAQ issues.

Solution: MFS was contracted to determine the source of the moisture problems, engineer solutions to those problems and install those solutions on the facility. Extensive testing revealed previously undetected sources of moisture entry into the building. Windows, doors, decks, EIFS/block intersections, parapet caps and other flashings were all moisture sources. Window/wall assemblies were sprayed and pressure tested. Remediation designs were refined from the testing and full elevations of the buildings were fitted with the modifications.

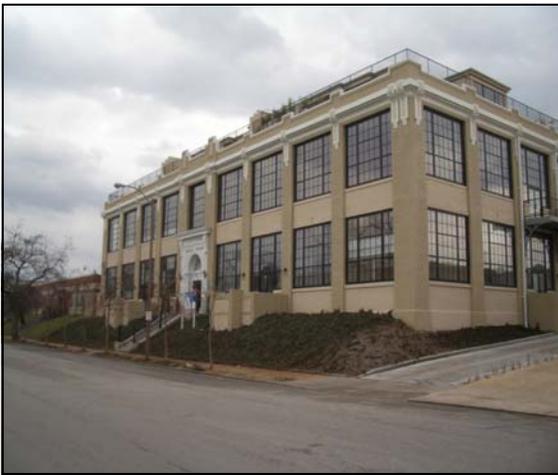
- 1927 MASS WALL CONSTRUCTION CONVERTED TO CONDOMINIUMS IN 2002
- DIRECT WATER PENETRATION THROUGH ALL OF THE NEW WINDOW AND DOOR SYSTEMS
- CONDO UNITS WERE UNMARKETABLE DUE TO MOISTURE ISSUES

All of the door systems failed the spray rack test (without negative pressure) within 30 seconds.

Windows failed through mullions, miters, and glazing locations.

Solution: MoistureFree Commercial Services was contracted to analyze the moisture problems in the building and determine if remediation was possible or if full door and window replacement would be required. MoistureFree conducted a series of tests on both the door and window systems and determined that modifications might be possible to manage the moisture intrusion. A solution was engineered for the door units to actively drain any moisture penetration through the door construction to the exterior through drainable threshold assemblies. The window systems were retrofitted with MoistureFree's DamSill™ system. The solutions were installed and tested with excellent results.

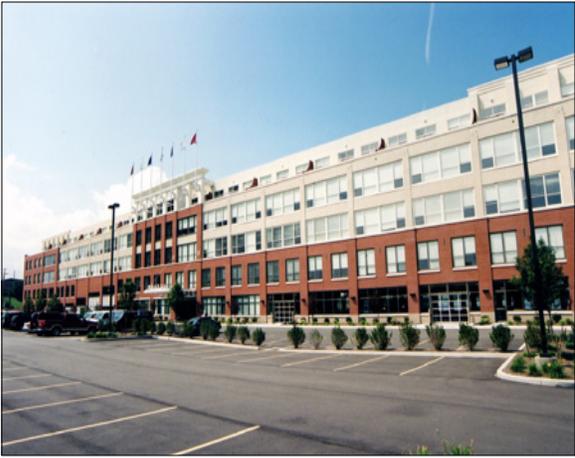
CASE STUDY—CLEVELAND, OH

- CONOMINIUM CONVERSION OF MASS WALL WAREHOUSE
- MOISTURE PENETRATION THROUGH FAULTY WINDOW DESIGN/INSTALLATION
- DIRECT MOISTURE PENETRATION TO THE INTERIOR LIVING SPACE AND IAQ ISSUES AFFECTING TENENTS

Forensic investigation revealed lack of flashing at the window sill. Moisture penetration through the window drained directly into an interior wall and created IAQ issues in many units.

The interior wall under the windows received most of the moisture from the windows causing damage to the steel stud and interior surfaces.

Solution: MoistureFree Commercial Services determine the source of the moisture problem related to the absence of a flashing elements and poor design of the window system itself. Retrofitting of the windows was possible without removal of the windows using MFCS's patented systems.

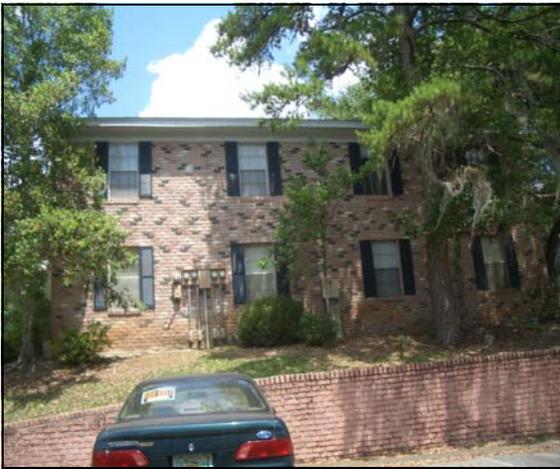
CASE STUDY—TALLAHASSEE, FL

- 136,000 SQ. FT., 14 BUILIND FACILITY. PORTLAND BASED STUCCO ON CMU.
- WATER PENETRATION THROUGH ALL OF THE WINDOW, DOOR AND DECK SYSTEMS
- OWNER HAD TO RESOLVE THE PROBLEM OR DEMOLISH THE BUILDINGS AND RE-BUILD

Infrared imaging helped reveal the multiple sources of moisture intrusion into the units. Hollow-core cantilevered concrete decks were a direct moisture source.

Retrofitting of the moisture source locations proved successful. Chronic leak areas were eliminated for the first time since the facility was built.

Solution: MoistureFree Commercial Services conducted thorough testing of the facility to determine the exact cause of the problem. It was determined that the previous remediation efforts were being made to the face of the wall systems, which was porous and allowed the moisture to bypass the modifications. MFCS successfully installed and tested active drainage modifications to the source locations, which controlled the leaks.
