CASE STUDY—CHARLOTTE, NC

- EIFS OVER CMU CONSTRUCTION WITH CURTAIN WALL WINDOW STACKS
- MOISTURE PENETRATION THROUGH ORIGINAL 1970'S WINDOWS
- PURCHASING CLIENT CONCERNED ABOUT EIFS APPLIED IN 1990 AND GENERAL BUILDING ENVELOPE PERFORMANCE

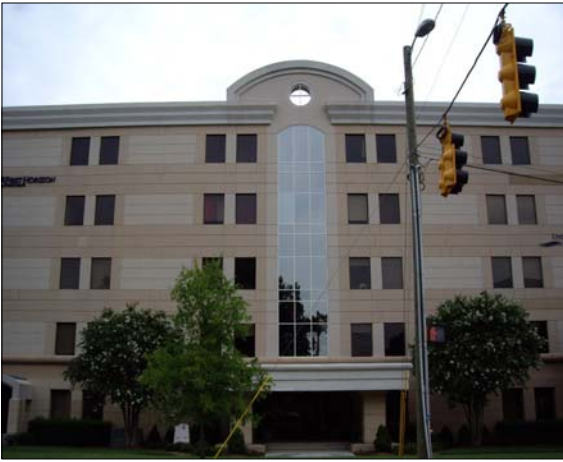
Open wall investigation revealed long term moisture migration into the window stacks. Moisture flowed down the stack and entered the interior working area at window heads.

It was determined the EIFS cladding had been installed over the exterior window sill blocking the window weeps. This forced moisture inward which flowed down the curtain wall.

Solution: MoistureFree Commercial Services investigation determined that the EIFS had a remaining useful service life of 20 years, provided that some maintenance and limited repairs were made. However, a serious moisture concern with the window systems was discovered, which had been affecting the building for many years.

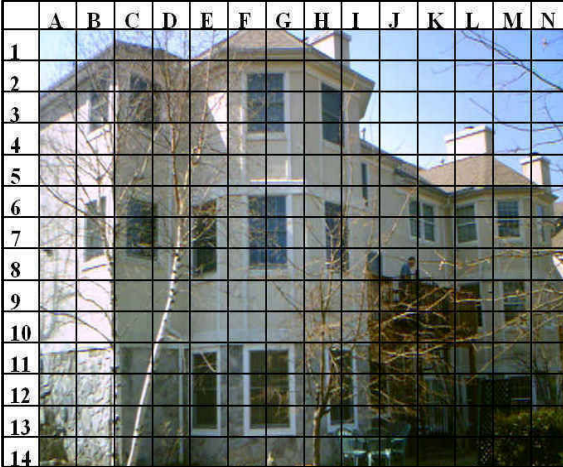
High moisture locations associated with windows occurred at a frequency nearly ten times less than average. Windows that did leak could be easily modified.

Failed flashing locations were the only significant location of moisture and damage. These limited areas did require repair and modification, but did not justify complete recladding.

Solution: MoistureFree Commercial Services was hired to provide expert witness services and analysis of the buildings. A thorough investigation of the buildings revealed that they were in excellent condition with the exception of limited flashing areas that required modification. MoistureFree's extensive database of more than 18,000 buildings and over 1.5 million data points provided solid evidence to back up the opinion that the buildings have a reliable cladding system. MoistureFree Commercial Services provided the estimated modification costs for the facility and backed the proposal with the guaranteed issuance of the MoistureFree Warranty following remediation by MFCS.

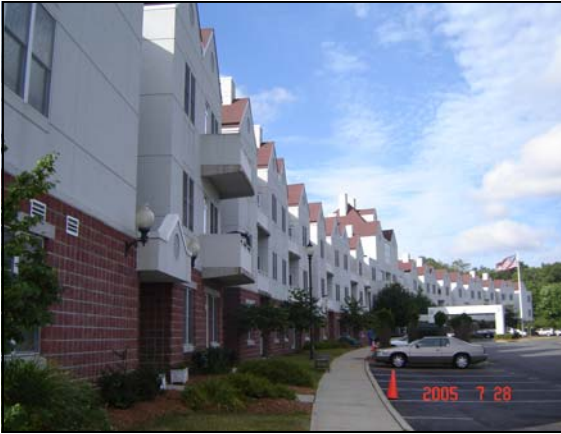
Spray rack and negative pressure testing of the windows revealed chronic problems in the windows design.

Interior damage to the steel stud walls was apparent in some areas of the facility. MoistureFree repaired these areas and eliminated the source of the IAQ issues.

Solution: MFS was contracted to determine the source of the moisture problems, engineer solutions to those problems and install those solutions on the facility. Extensive testing revealed previously undetected sources of moisture entry into the building. Windows, doors, decks, EIFS/block intersections, parapet caps and other flashings were all moisture sources. Window/wall assemblies were sprayed and pressure tested. Remediation designs were refined from the testing and full elevations of the buildings were fitted with the modifications.

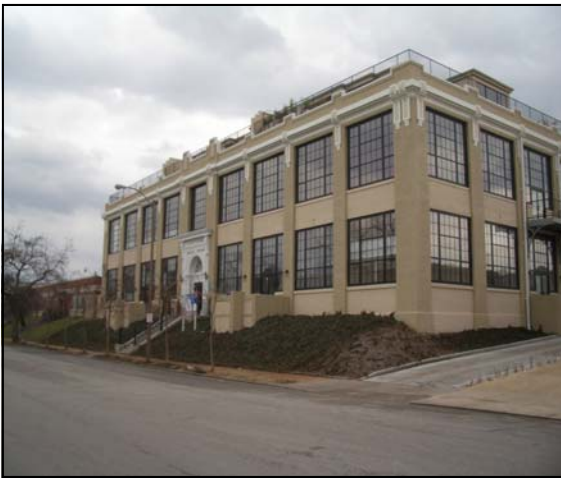
All of the door systems failed the spray rack test (without negative pressure) within 30 seconds.

Windows failed through mullions, miters, and glazing locations.

Problem: Over a period of two years, the window/door manufacturer, installer, and third-party had made numerous attempts to repair and modify the failing door and window systems with no success. Moisture damage to floor systems, failed remediation costs, delays in sales, and other expenses totaled more than \$300,000. Complete replacement of the door and window systems was proposed at an additional cost of more than \$700,000.

Solution: MoistureFree Commercial Services was contracted to analyze the moisture problems in the building and determine if remediation was possible or if full door and window replacement would be required. MoistureFree conducted a series of tests on both the door and window systems and determined that modifications might be possible to manage the moisture intrusion. A solution was engineered for the door units to actively drain any moisture penetration through the door construction to the exterior through drainable threshold assemblies. The window systems were retrofitted with MoistureFree's DamSill™ system. The solutions were installed and tested with excellent results.

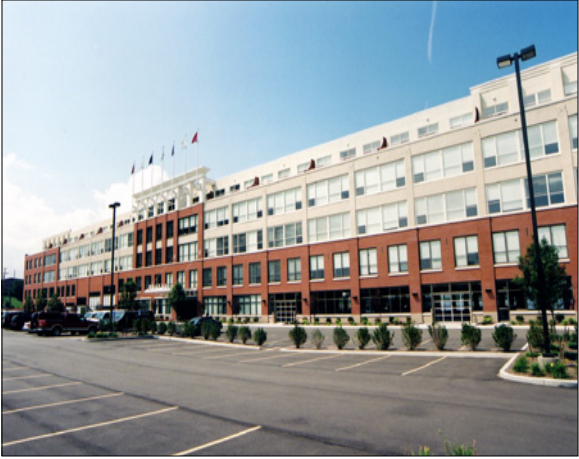
Forensic investigation revealed lack of flashing at the window sill. Moisture penetration through the window drained directly into an interior wall and created IAQ issues in many units.

The interior wall under the windows received most of the moisture from the windows causing damage to the steel stud and interior surfaces.

Solution: MoistureFree Commercial Services determine the source of the moisture problem related to the absence of a flashing elements and poor design of the window system itself. Retrofitting of the windows was possible without removal of the windows using MFCS's patented systems.

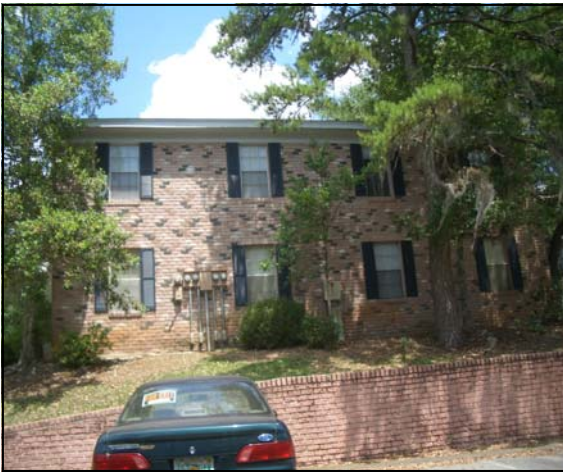
Infrared imaging helped reveal the multiple sources of moisture intrusion into the units. Hollow-core cantilevered concrete decks were a direct moisture source.

Retrofitting of the moisture source locations proved successful. Chronic leak areas were eliminated for the first time since the facility was built.

Solution: MoistureFree Commercial Services conducted thorough testing of the facility to determine the exact cause of the problem. It was determined that the previous remediation efforts were being made to the face of the wall systems, which was porous and allowed the moisture to bypass the modifications. MFCS successfully installed and tested active drainage modifications to the source locations, which controlled the leaks.
